Property Inspection Report

South Jersey Area

Age of Home: Built 1925 Size: 1,314 sq. ft.

20 5th Avenue, Cherry Hill, NJ 08003

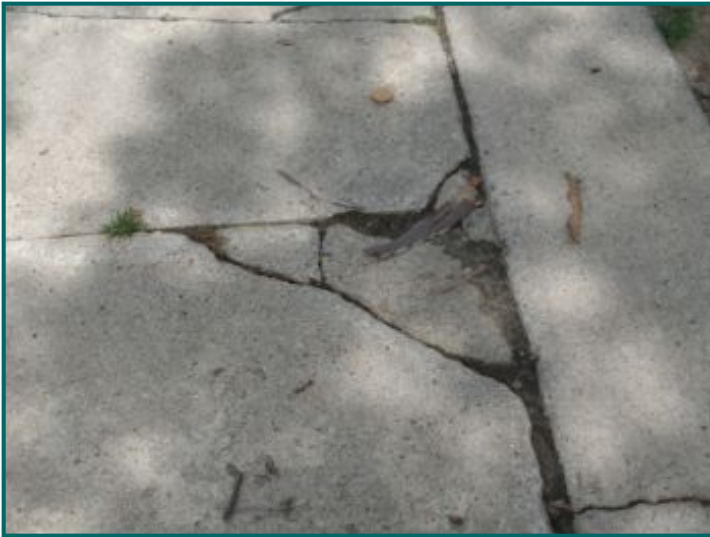
- Extensive cracking noted in portions of driveway. Over time, they may present a trip hazard. Repairs by a qualified contractor recommended.

Damaged driveway surface.

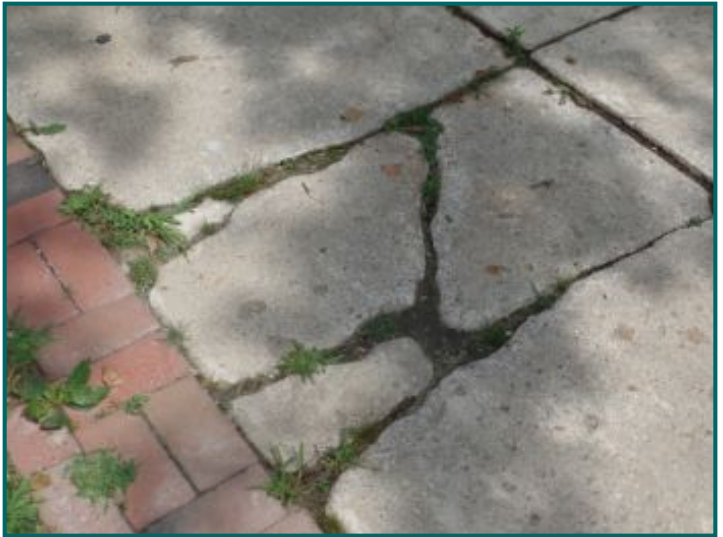
Damaged concrete.

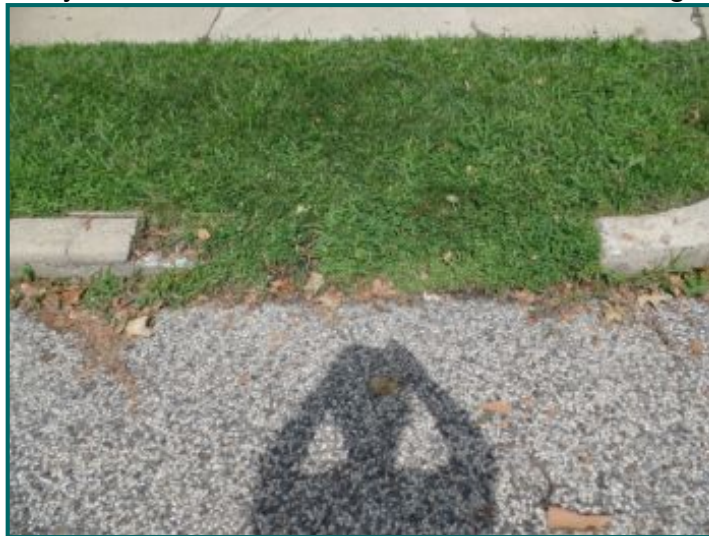
Missing section of curb.

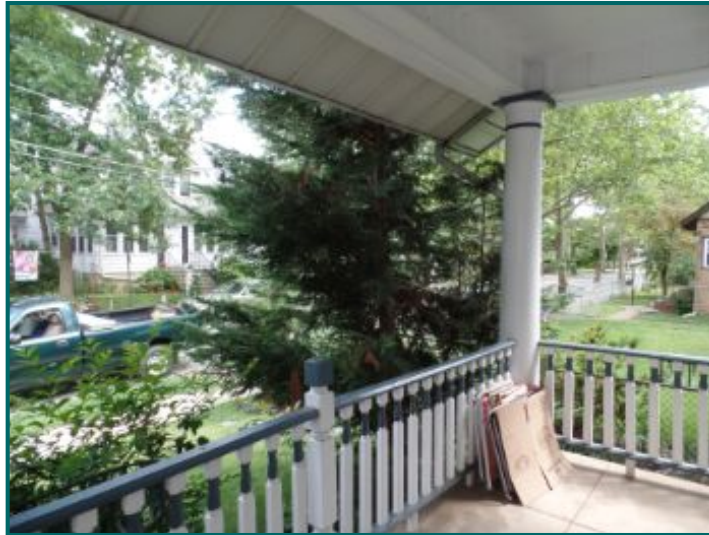
Tree in contact with home.

- Maintenance Tip: When landscaping, keep plants, even at full growth, at least a foot (preferably 18 inches) from house siding and windows. Keep trees away from foundation and roof. Plants in contact or proximity to home can provide pathways for wood destroying insects, as well as abrade and damage siding, screens and roofs.

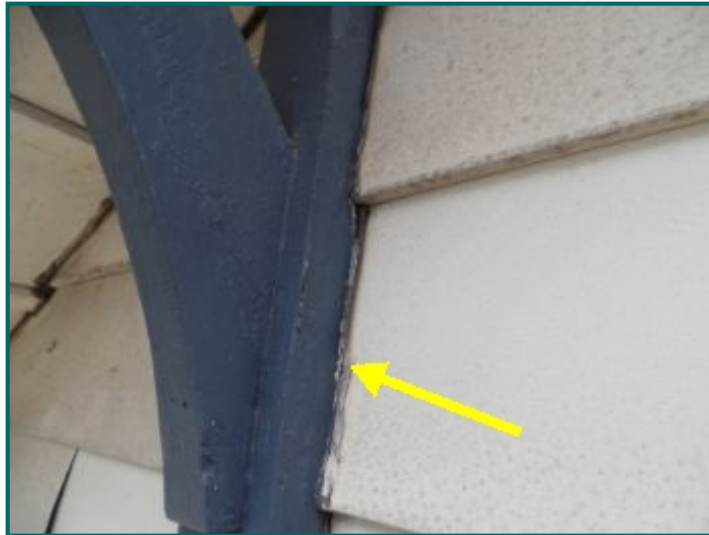
- A chalky film was observed on the siding surface. This is common with aging of flat exterior paint. The inspector recommends a thorough cleaning and rinsing of siding before any re-painting is done.
- Extensive caulking observed at siding/soffit joints, around outrigger trim, and other areas. Caulk prevents moisture and insect intrusion to the structure and should be monitored on a yearly basis and repaired as necessary.

Caulking maintenance required.

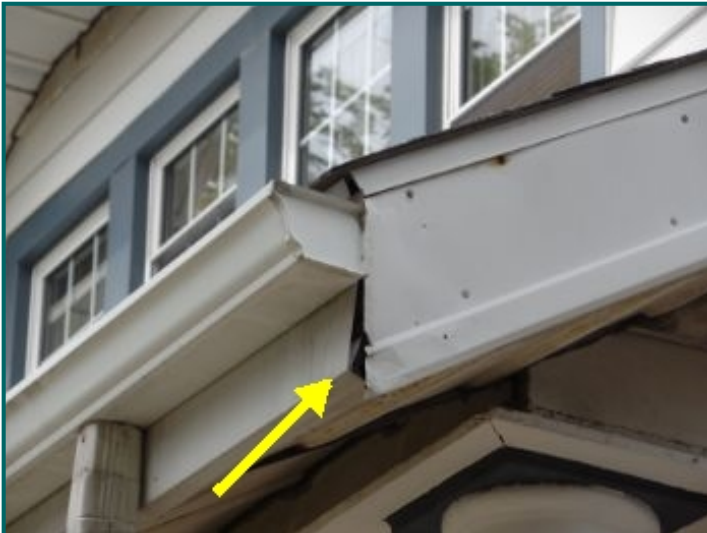
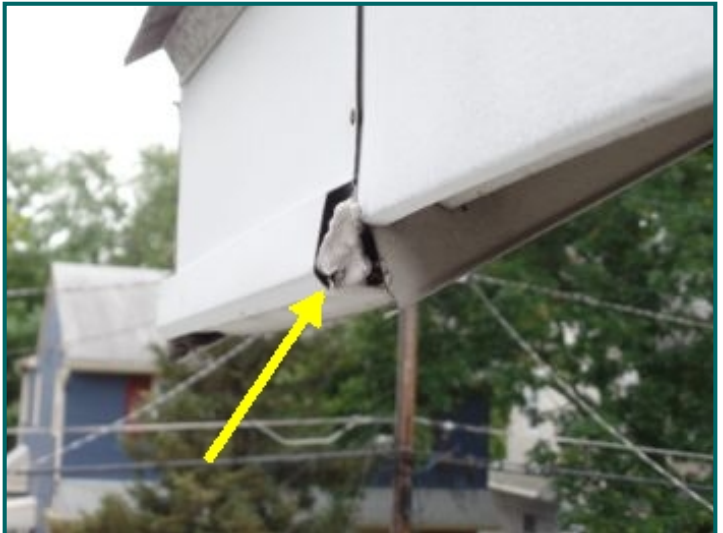
- The metal fascia capping protects the wood underneath from moisture and insect damage. Open seams should be repaired by a qualified contractor.

Open fascia seam.

Open seam.

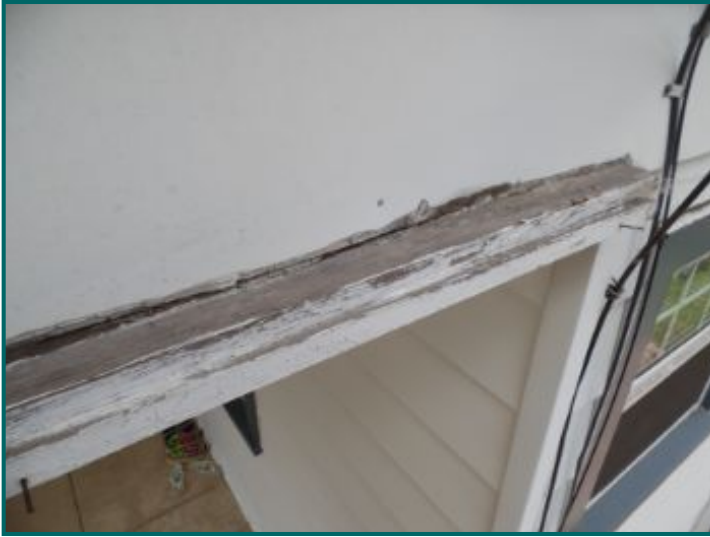
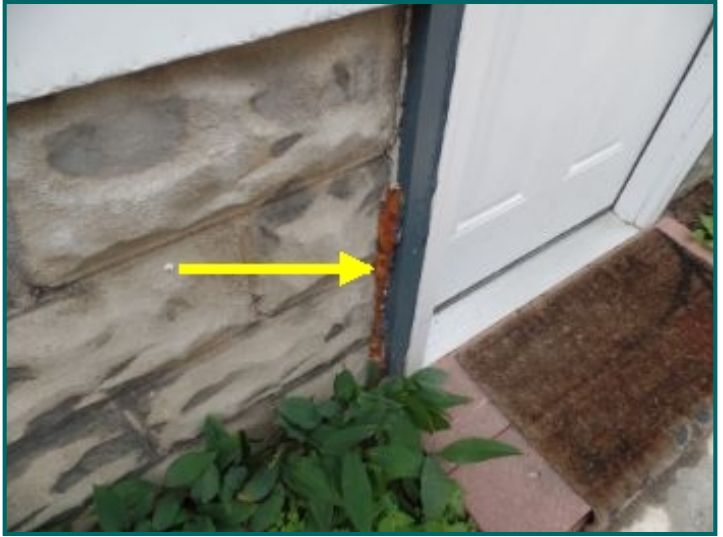
- Deterioration of outrigger post ends observed. These areas will require yearly monitoring and maintenance.
- Loose, peeling paint and deteriorated caulking observed at wood trim at right side of porch ceiling. This area is directly affected by wind driven rain and should be re-caulked and painted.
- Foam sealant is not recommended for exterior applications, and should be replaced by proper sealant.

Failed caulking.

Foam caulking.

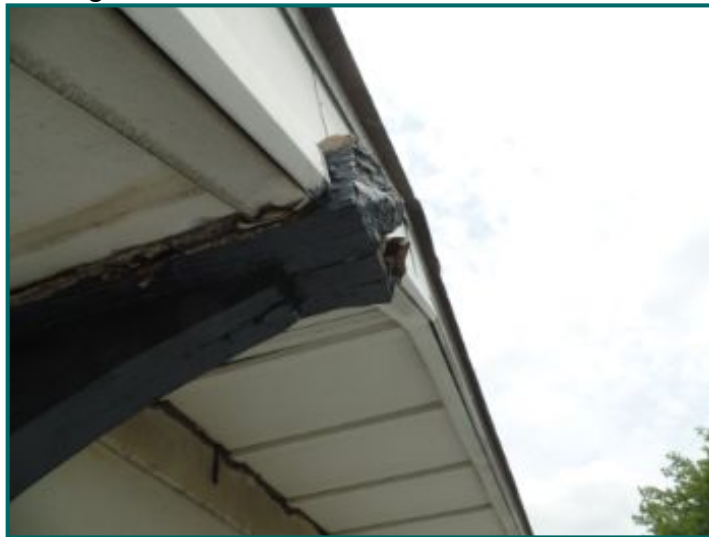
Damage at outrigger ends.

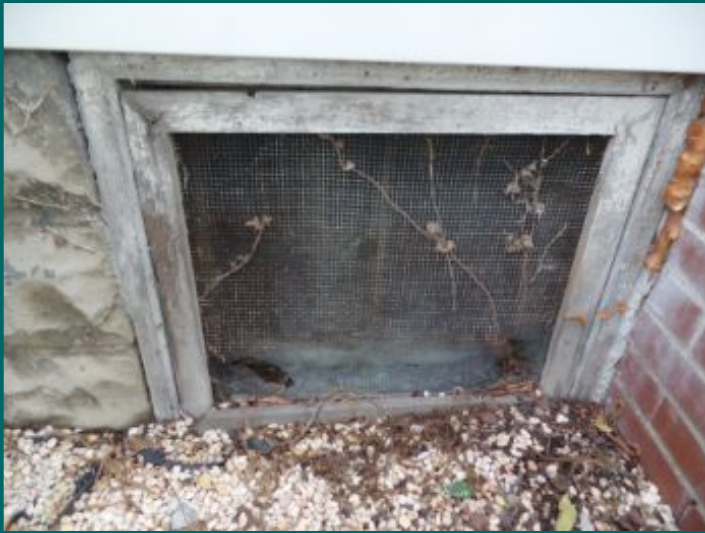
- Some basement window frames were in direct contact with soil. This can lead to moisture and insect damage. All basement windows are in some state of disrepair. The inspector recommends repair and re-painting of basement windows by a qualified contractor.

Wood/soil contact.

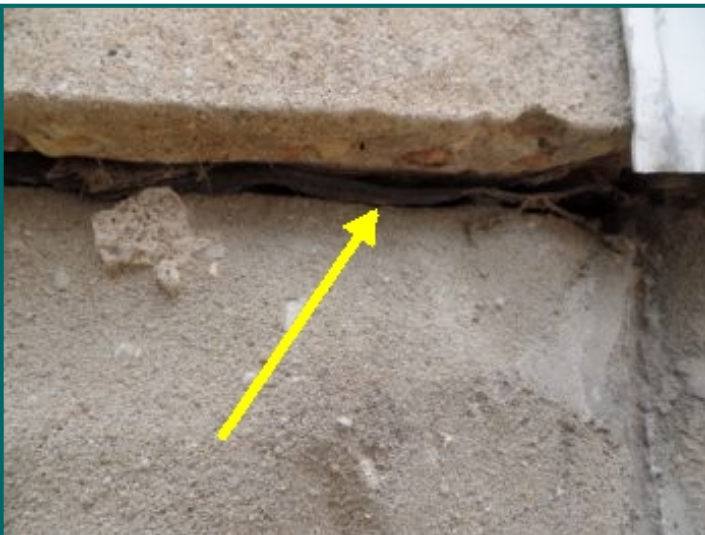
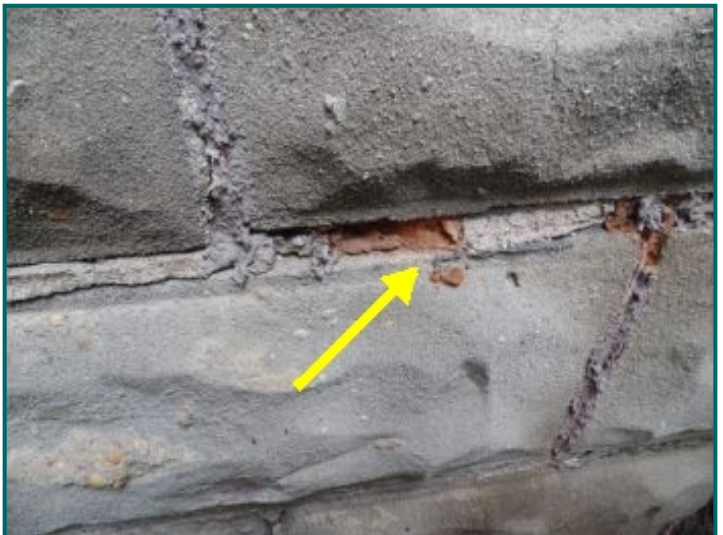
- Open masonry joints are pathways for moisture and insect intrusion. Gaps should be sealed with mortar or other recommended masonry sealant.

Recommend sealing all masonry joints.

Foam sealant.

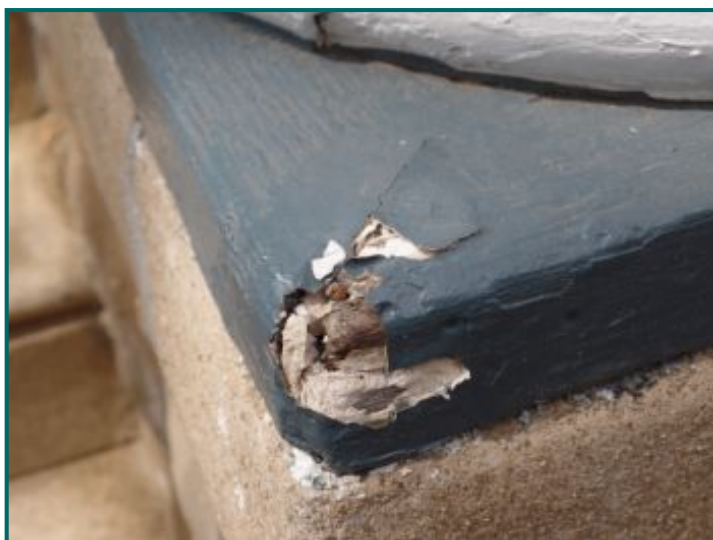
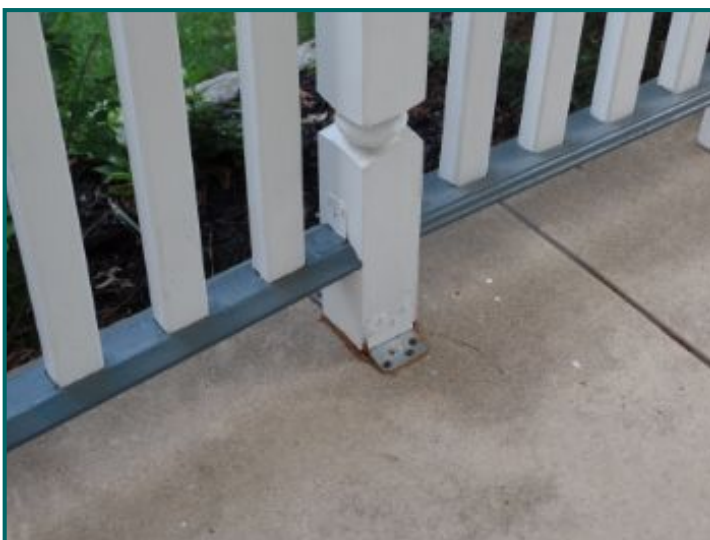
- Damaged column base observed at right front porch.
- Front porch guardrail center post is inadequately fastened and loose. The guardrail could fail if someone leans hard on it. Recommend replacing existing angle brackets with heavier duty hardware.

Moisture damage at column base.

Loose center guardrail post.

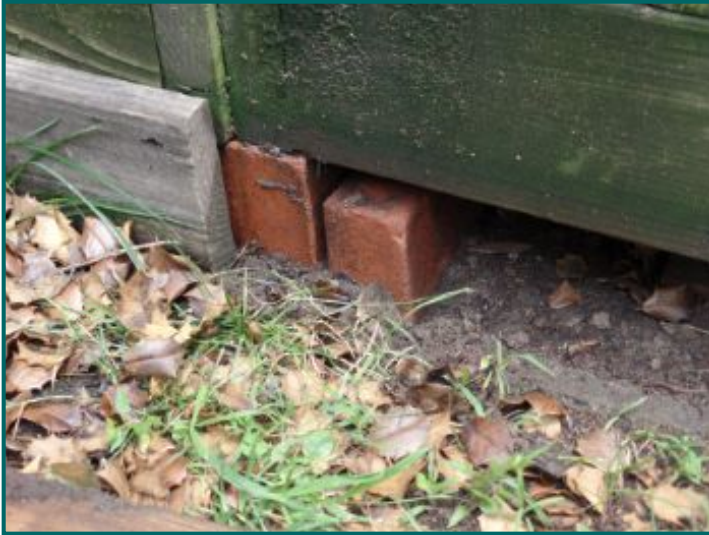
- Garage was locked, preventing access. Interior was not inspected.
- Deck supported by bricks only. No footings observed.
- Deck was covered by outdoor carpeting. Deck boards were not inspected.
- Missing soffit panel observed at right side of garage. This is a pathway for animals and should be replaced.

No solid footings.

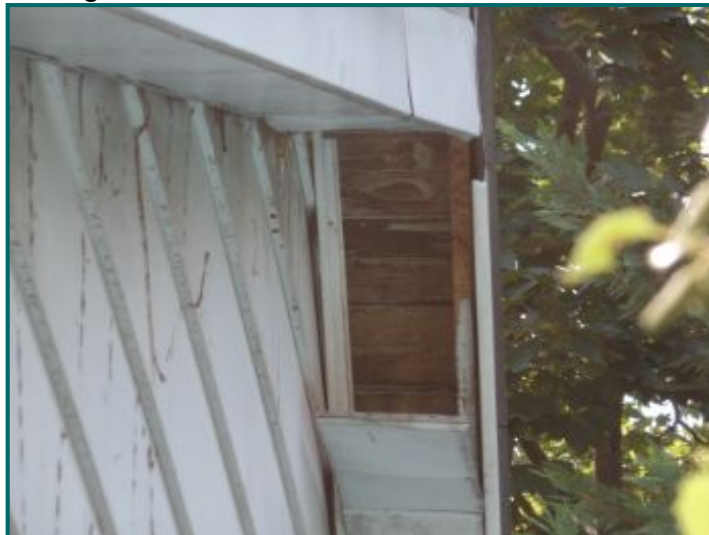
Missing soffit panel.

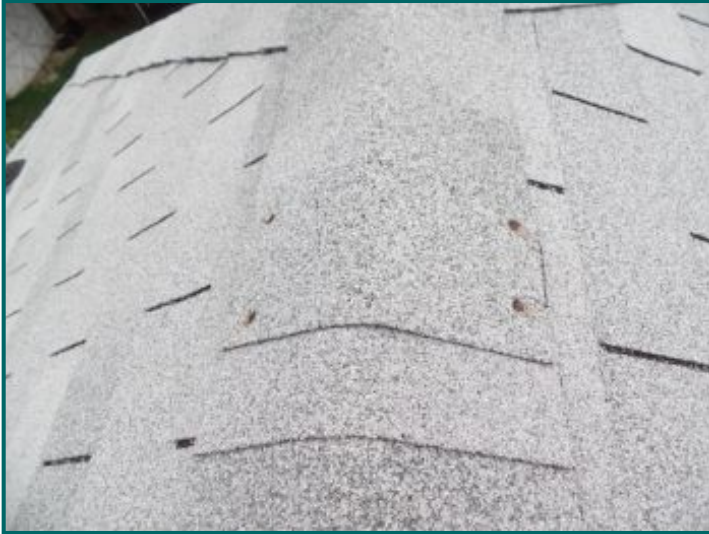
- No major system safety or function concerns noted with roof covering material at time of inspection. Other issues are mentioned below:
- We recommend installing wire mesh in both corners of the front dormer to prevent squirrel damage to shingles and sheathing, and to prevent bird nesting.
- **Exposed nails on roofing material. Recommend sealing all fastener heads to prevent corrosion.**

Exposed roofing nails.

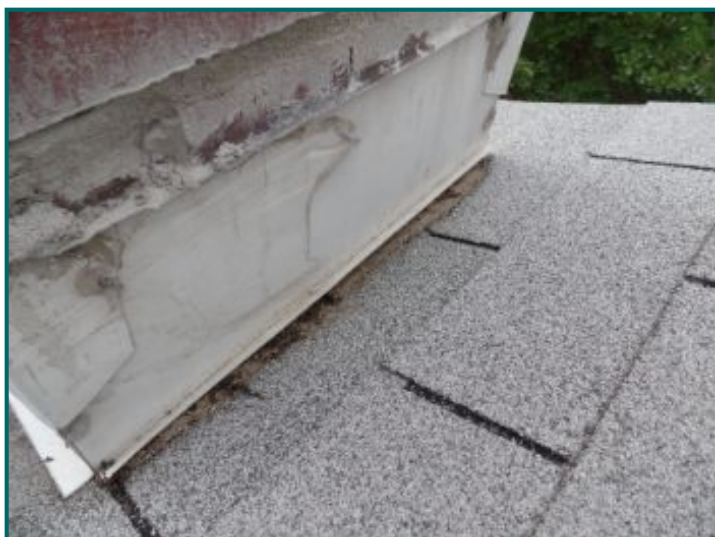
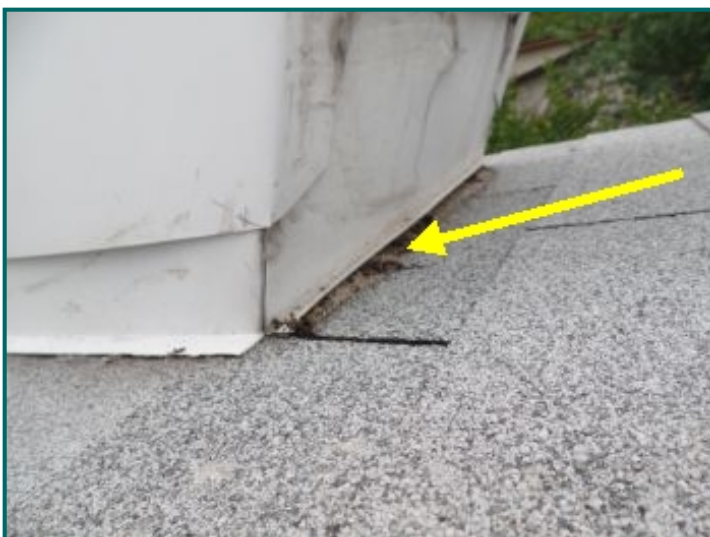
- **It appears the flashing at the high slope end of the chimney does not extend below the roof shingles. If not properly flashed, moisture can penetrate the structure and cause structural damage. We recommend further evaluation of the chimney flashing by a qualified contractor.**

Chimney flashing.

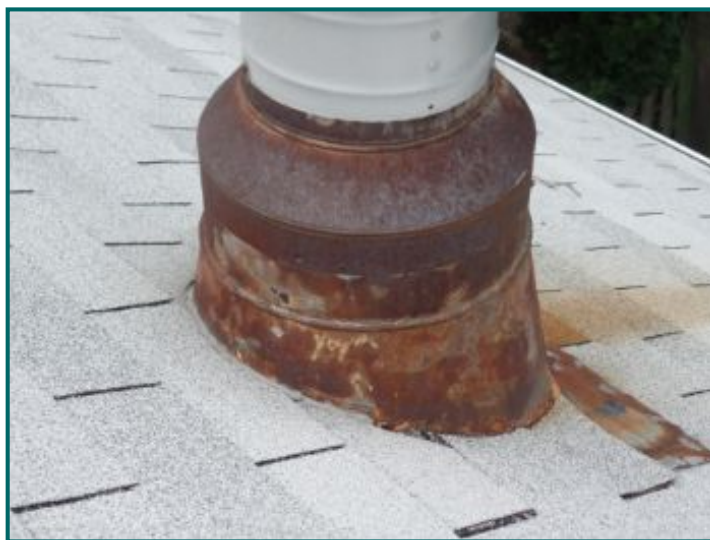
- Severe rusting observed on turbine vent housing. The inspector recommends replacement of turbine vent with a powered exhaust fan to increase attic ventilation. At the very minimum, the housing should be properly prepped and painted to prevent further corrosion of metal and roof staining.

Rusted turbine vent.

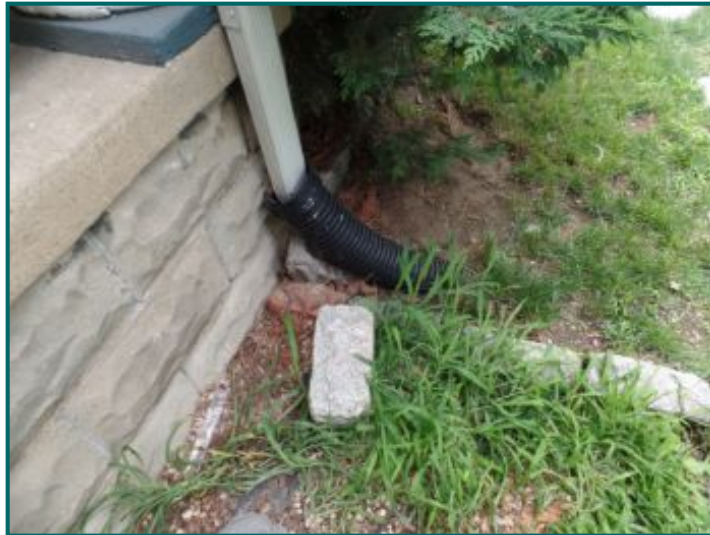
- One or more leader(s) appeared to be draining underground. The inspector could not determine the exit point of this drain. We recommend consulting with seller to find out where the drains go.

Termination point undetermined.

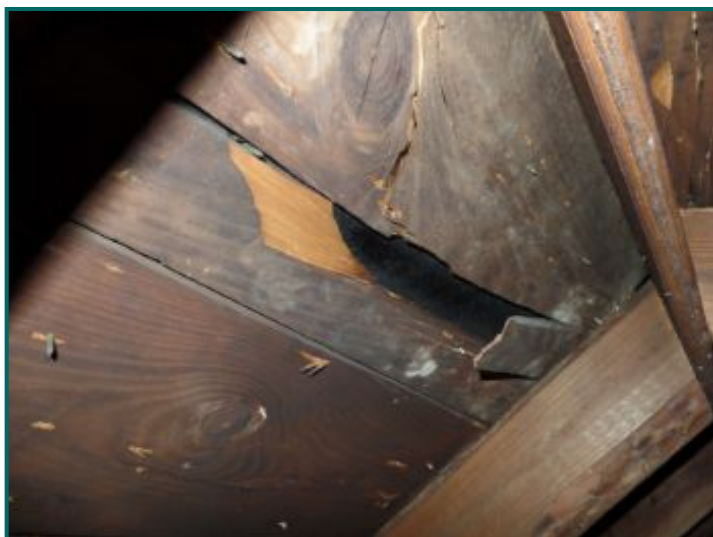
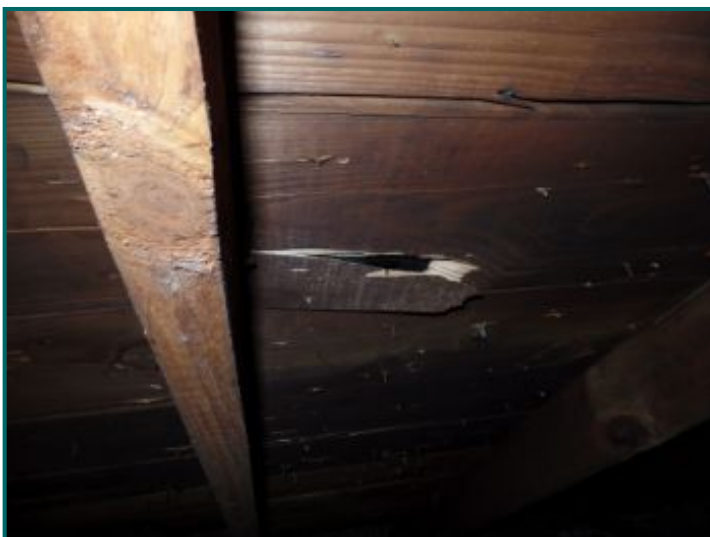
- Offset roof rafters were an acceptable practice when home was originally constructed. No distortion of ridge board was observed.
- **Damaged roof sheathing should be reinforced to prevent soft spots in roofing material.**

Damaged roof sheathing.

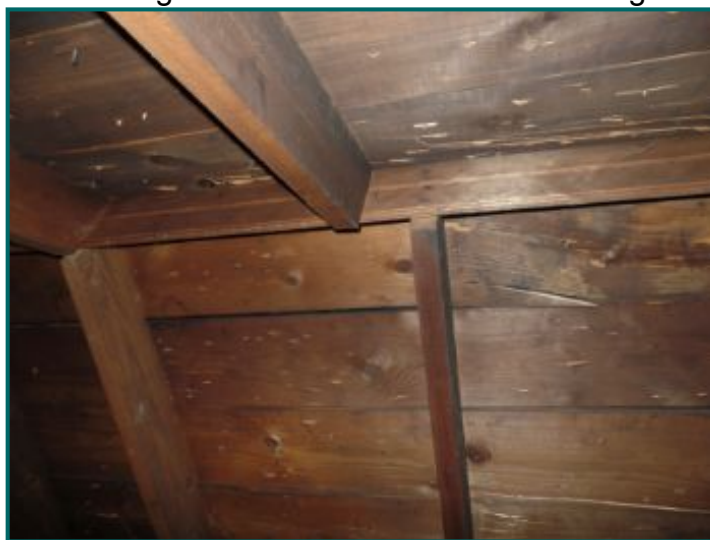
Offset roof rafters.

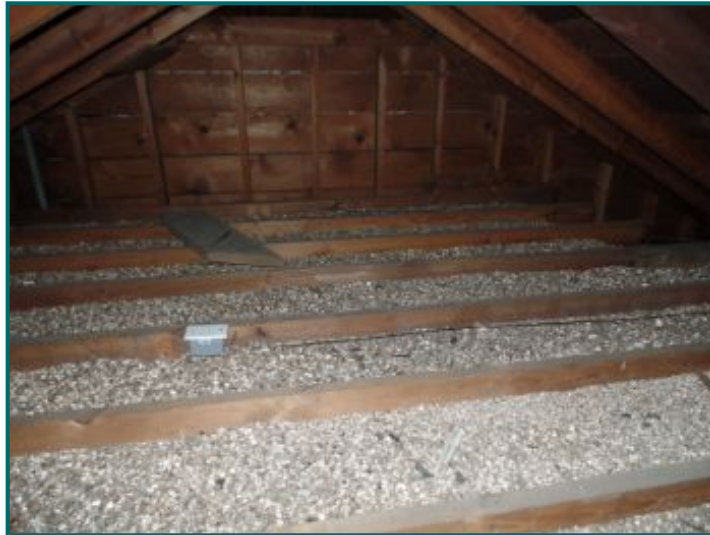
- Insulation averages less than 3 inches in depth. Additional insulation recommended.

• Vermiculite insulation present in attic. Much of the vermiculite used for insulation from the 1920's through the 1990's was mined at the Libby Mine in Montana. The vermiculite from this mine was contaminated with tremolite, a type of asbestos. Exposure to airborne asbestos particles has been associated with a number of respiratory diseases. The Environmental Protection Agency recommends the following when vermiculite insulation is present in a home:

Vermiculite insulation.

- (1). Do not disturb the insulation.
- (2). Do not use the attic for storage.
- (3). Do not allow children to play in the attic.
- (4). Do not attempt to remove the insulation yourself.
- (5). Hire a qualified asbestos contractor if you plan to remodel or conduct renovations that would disturb the vermiculite in attic or walls to make sure the material is safely handled and/or removed. The Inspector recommends having the vermiculite tested for asbestos contamination by a qualified contractor, and consultation with a qualified asbestos contractor concerning remediation of issues that may arise if testing is positive.

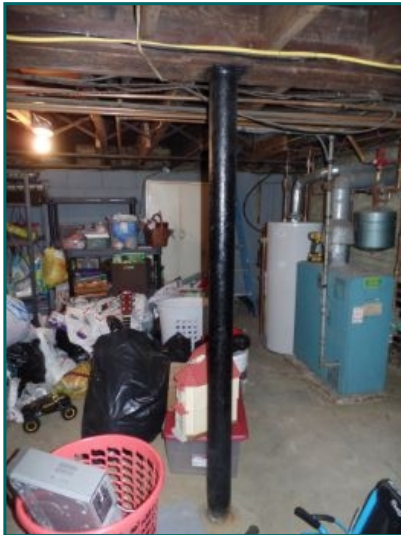
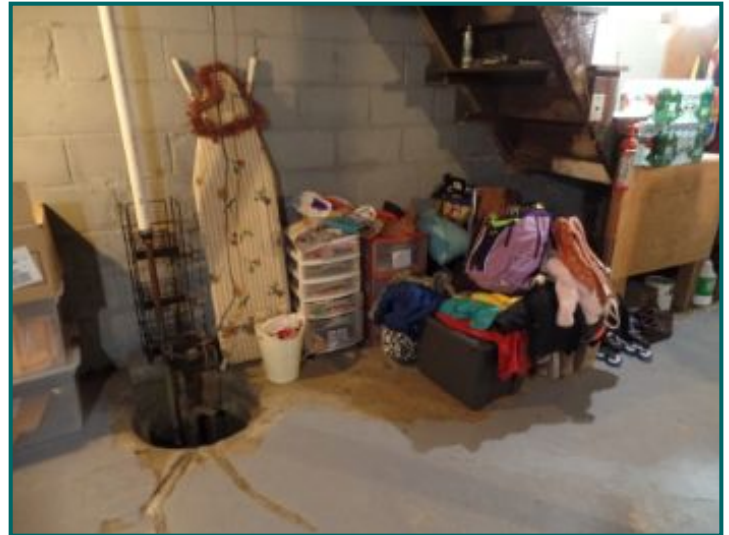
- Storage of personal items prevented inspection of parts of foundation wall and floor.

Stored items.

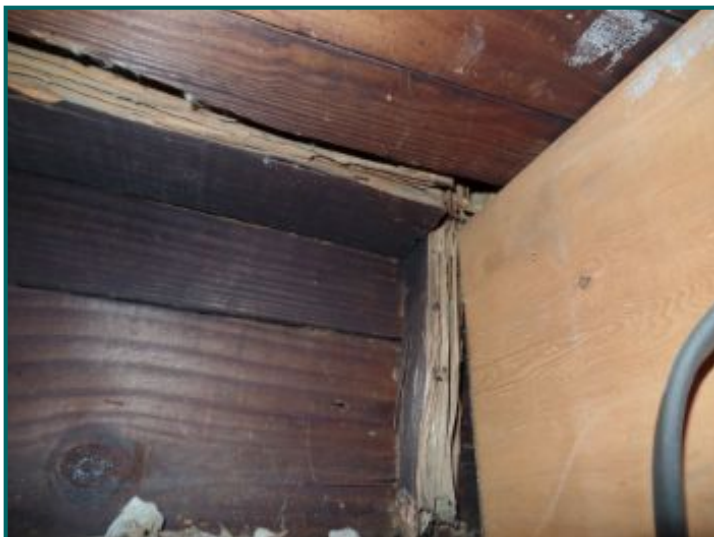
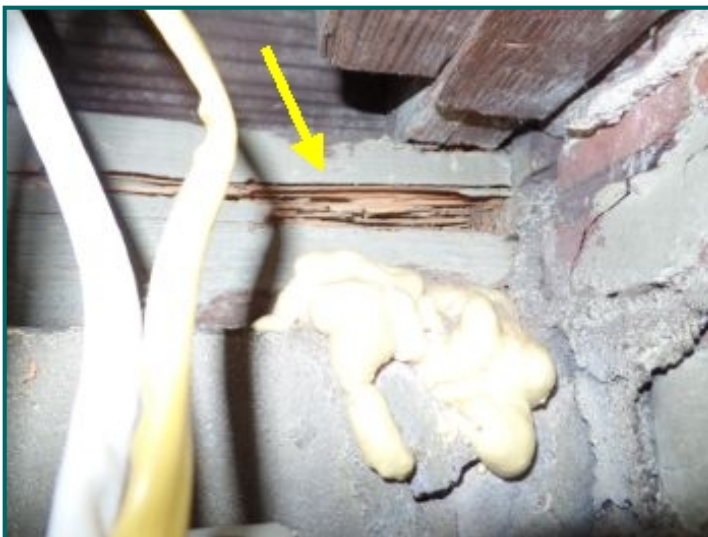
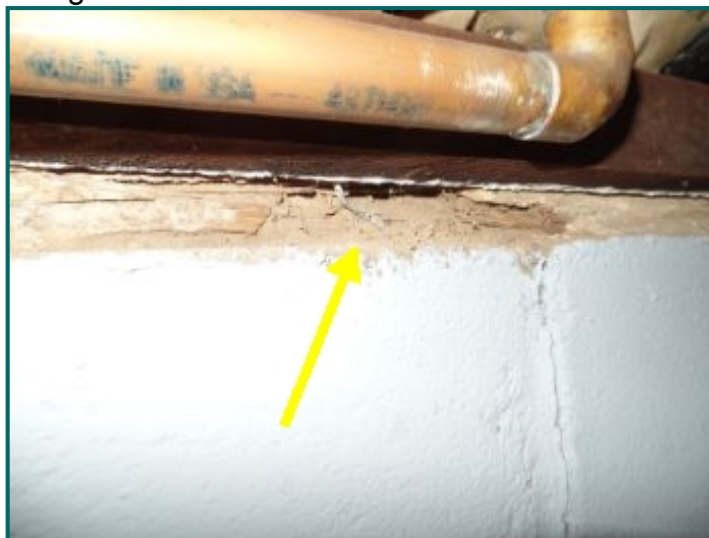
- Dimensional lumber floor joists noted.
- Dimensional lumber built up main beam noted.
- Dimensional lumber wall studs noted.
- Insect damage to sill plate and wall studs observed in several areas of basement. It appears that some damage extends up into wall cavity in front left corner of home. The inspector recommends evaluation by a qualified contractor for repair estimates.

Insect damage.

Insect damage at sill plate.

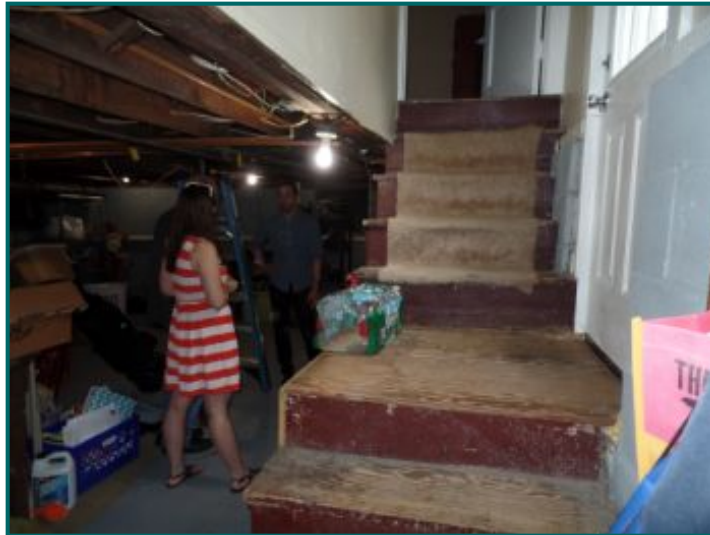
- Modern building standards require a graspable handrail for stairs with 4 or more risers. We recommend the installation of a continuous handrail in the basement stairwell for safety concerns.
- Missing guardrails observed. This is a "Safety Concern". Although guardrails may not have been required when the home was built, we recommend client consider installing guardrails as a safety enhancement.

No safety handrail or guard rails.

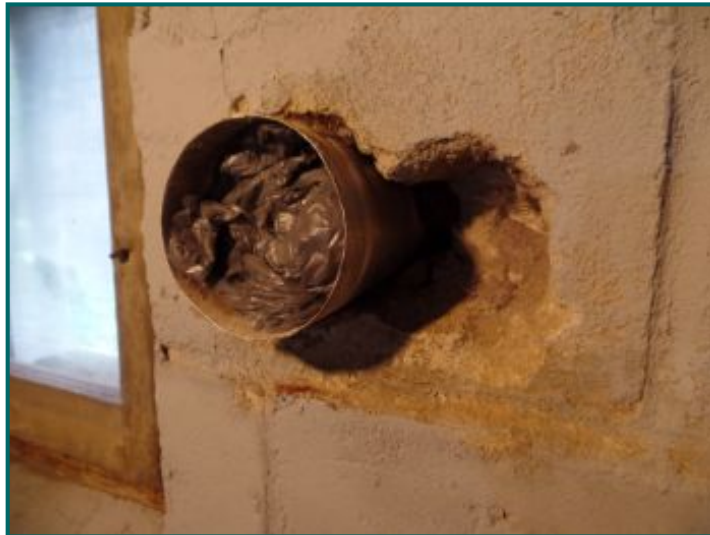
- Hole in block wall at abandoned dryer vent should be filled with mortar to prevent further deterioration.

Hole in block.

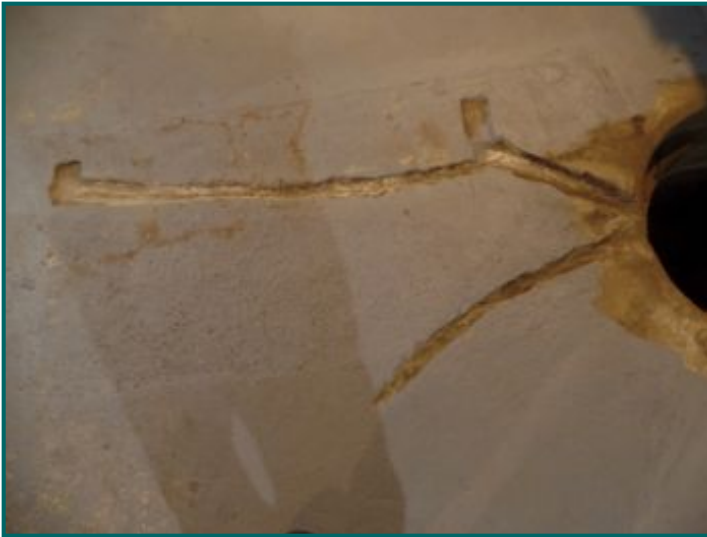
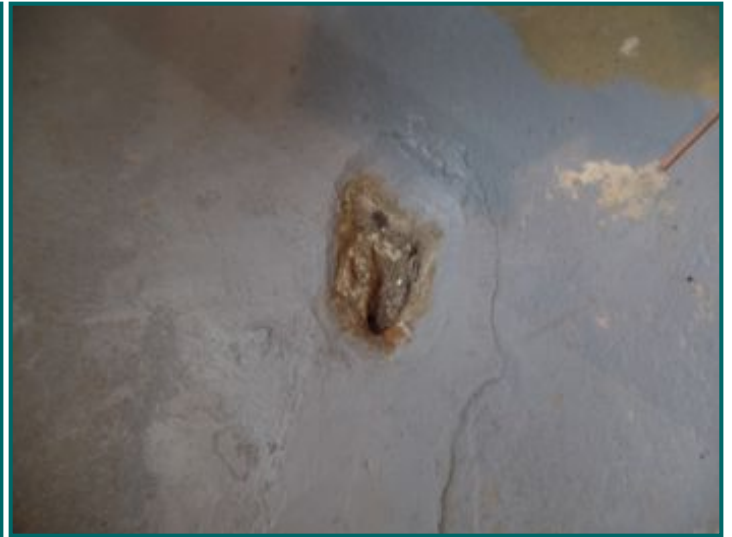
- Concrete slab floor noted.
- Grooves and hole in slab floor should be filled with mortar, as they present a trip hazard.

Deep grooves in floor.

Hole in floor.

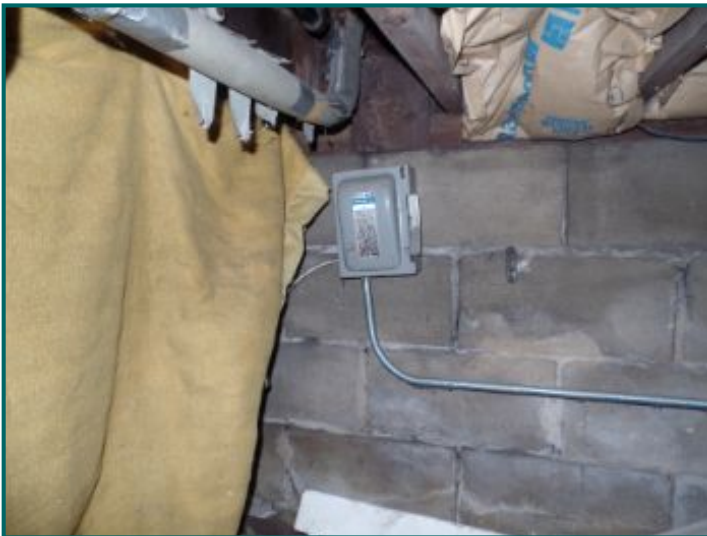
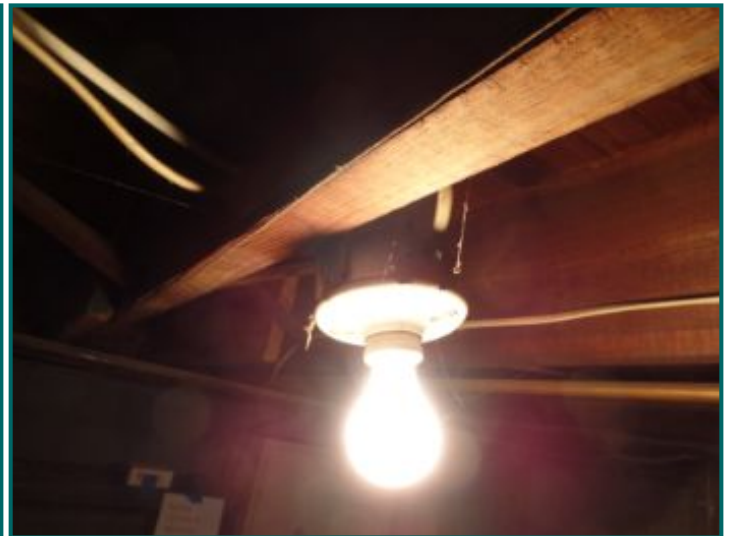
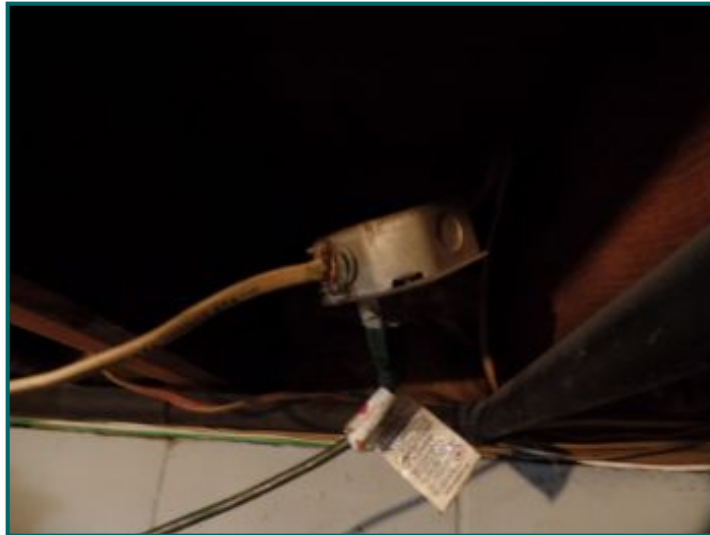
- 3 phase switch observed in basement crawlspace. The purpose of this switch is unclear, as there is no 3 phase wiring in home. The inspector recommends consulting with the owner as to purpose of this switch.
- A loose receptacle box and light fixture was observed in the basement. This can be a shock hazard, and should be repaired by a qualified contractor.

Purpose of switch?

Loose fixture.

Loose junction box in basement.

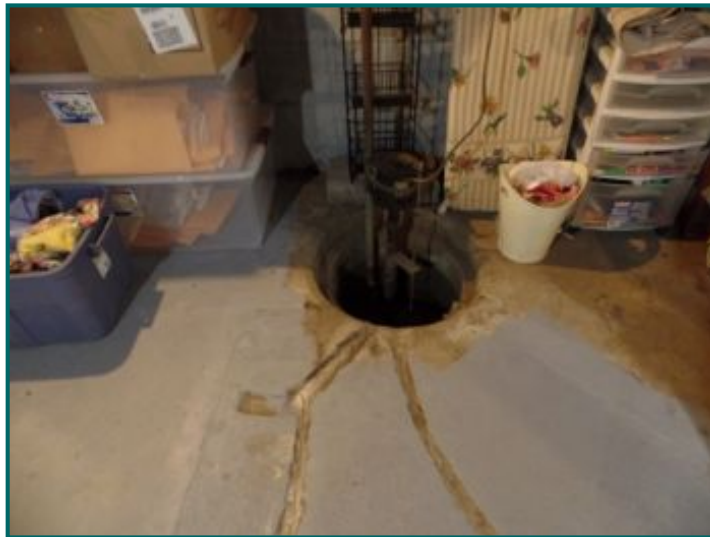
- The basement sump pump was operational when tested.
- Installation of sump well cover recommended.

Open sump pit.

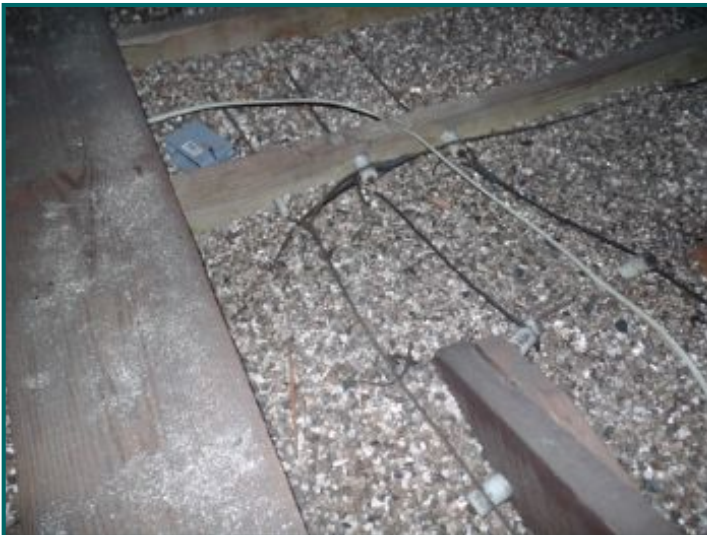
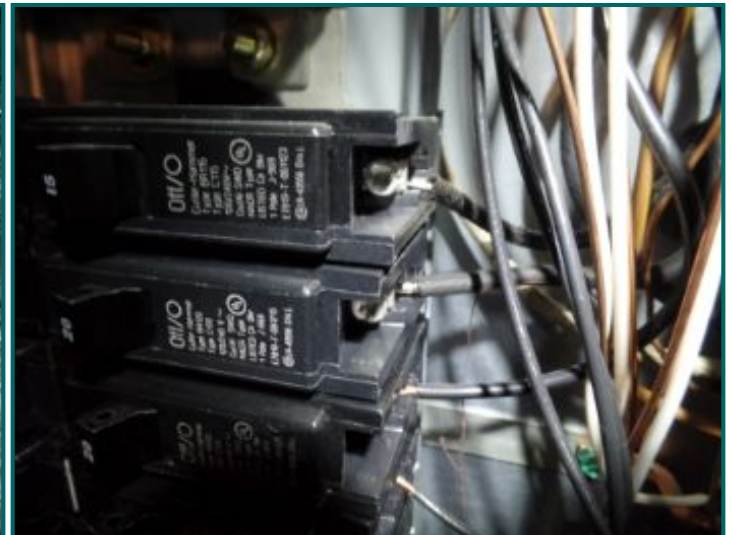
• Two branch circuits appear to be single strand aluminum wire. Certain safety issues, such as overheating, loose connections, and oxidation have been associated with this type of wiring. The inspector recommends evaluation and possible replacement of these suspect circuits by a qualified electrical contractor.

• The residence is partially wired with knob and tube wiring. Knob and tube wiring can be presumed to be the original electrical wiring in the home and old and outdated by today's safety standards. Problems with knob and tube wiring are as follows: (1) Limited wire size in this type of wiring system can cause wires to be loaded beyond safe capacity by the use of multiple modern appliances; (2) Repeated overheating of the wiring over the years can cause the protective wire insulation to harden, crack, and break off, leaving energized wires exposed to touch and creating a fire hazard; (3) Knob and tube wiring is designed to maintain a safe temperature by radiating heat into the surrounding air. Because it is common for insulation to be added to homes to save on heating costs, wires are often buried in insulation which may create a fire hazard. (4) Improperly splicing the wiring. I recommend replacing this outdated wiring system with modern wiring. You should consult with a qualified electrical contractor to determine options and costs to cure. The inspector is aware of some insurance companies that decline to provide homeowner's insurance if active knob & tube wiring is present. It is recommended that you contact your preferred insurance company before close of escrow to ensure that appropriate homeowner's insurance can be obtained on the structure. It is also recommend having a qualified electrical contractor evaluate the system and provide repair costs and options prior to the close of escrow.

Live knob & tube wiring.

Solid aluminum wiring.

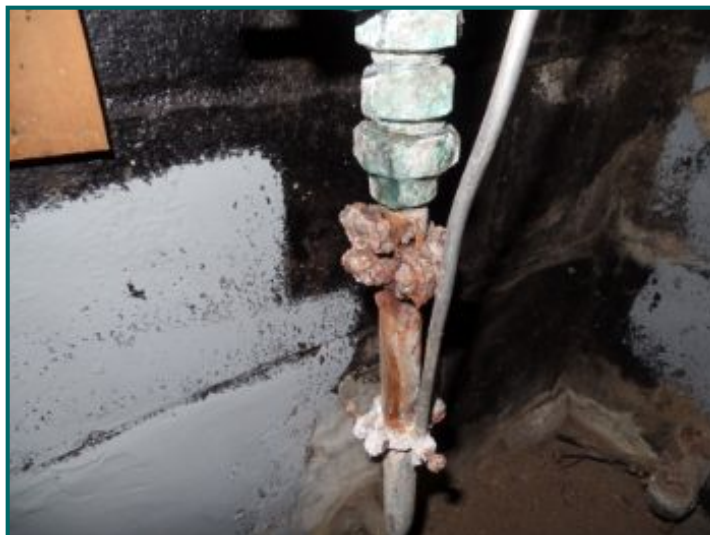
- Severe corrosion and active leaking was observed in the service entrance piping at the main water shut off valve. See: "MAIN WATER SHUTOFF".

Corrosion and active leak at entrance piping fitting.

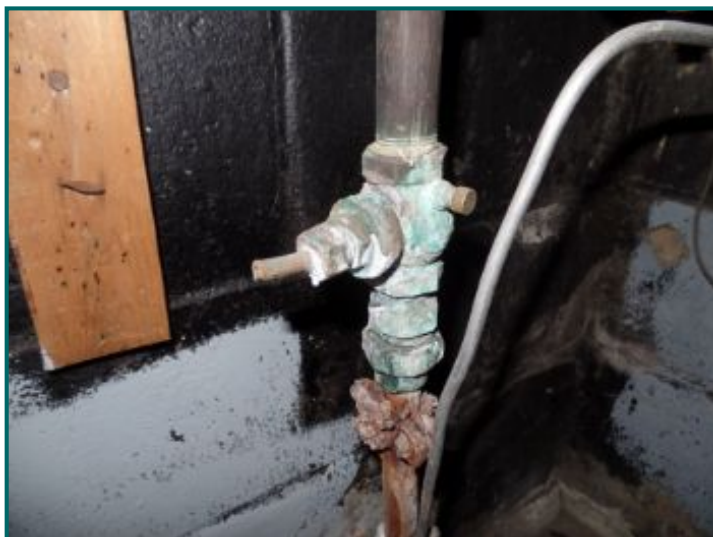
- Corrosion and missing handle observed at main water shut off valve. Replacement of entire valve by a qualified plumbing contractor is recommended.

Corroded/inoperable water main shut off valve.

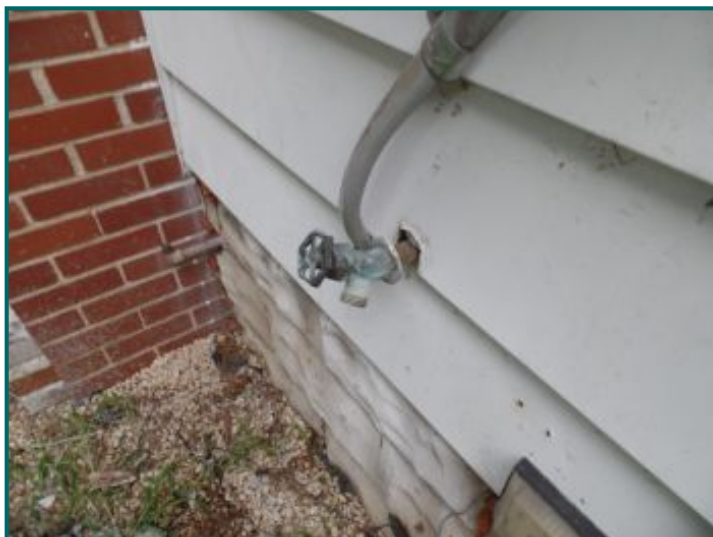
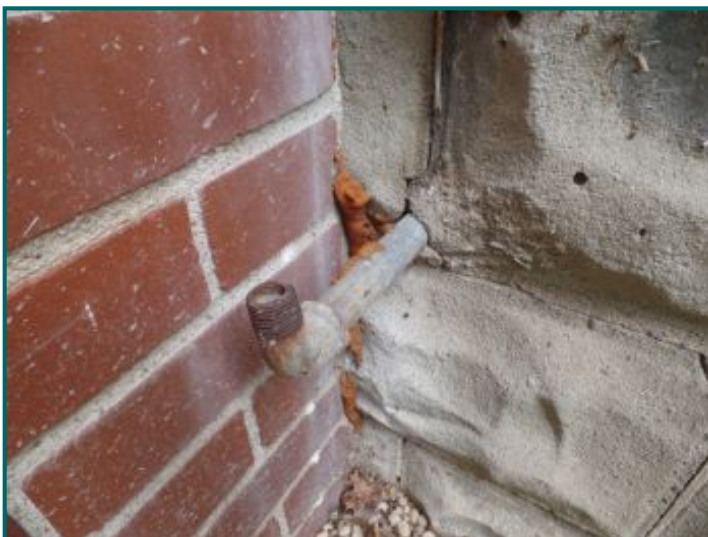
- Left exterior hose bib has been disconnected and is loose in the wall. Replacement is recommended.
- Galvanized pipe, which may be abandoned water supply line, should be removed from wall, and hole patched with mortar.

Repair/replace faucet.

Remove abandoned pipe.

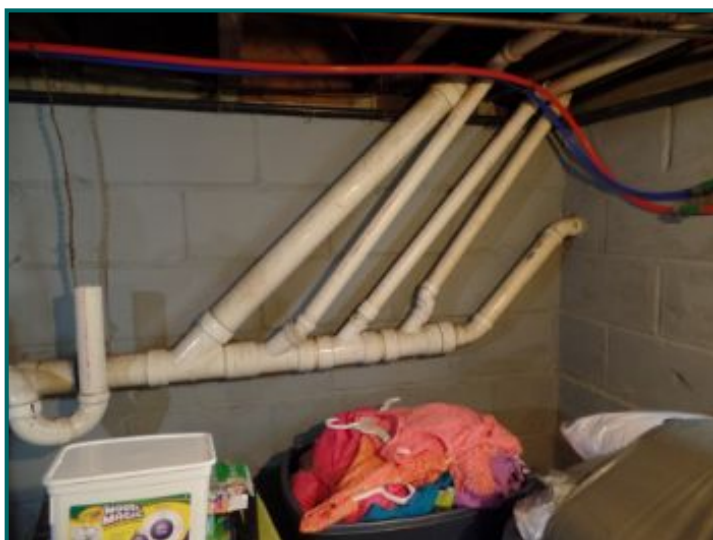
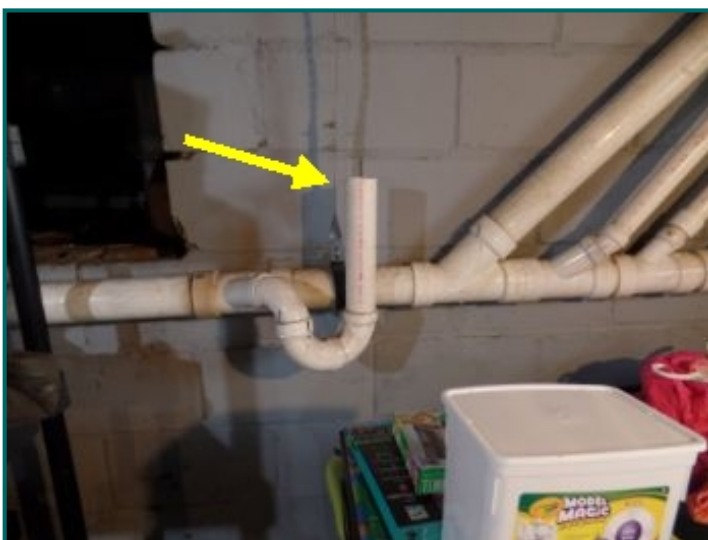
- No deficiencies noted at time of inspection except as noted below:
- Improper slope of drain lines observed in manifold at rear left corner of basement. Improper slope of drain lines can lead to blockage. The inspector recommends evaluation of the entire drain manifold and vent pipe by a qualified plumbing contractor.
- Open drain line observed in basement. This may have served a washing machine in the past, and should be capped to prevent toxic sewer gas from entering basement.

Suspect drain manifold.

Open vent in basement.

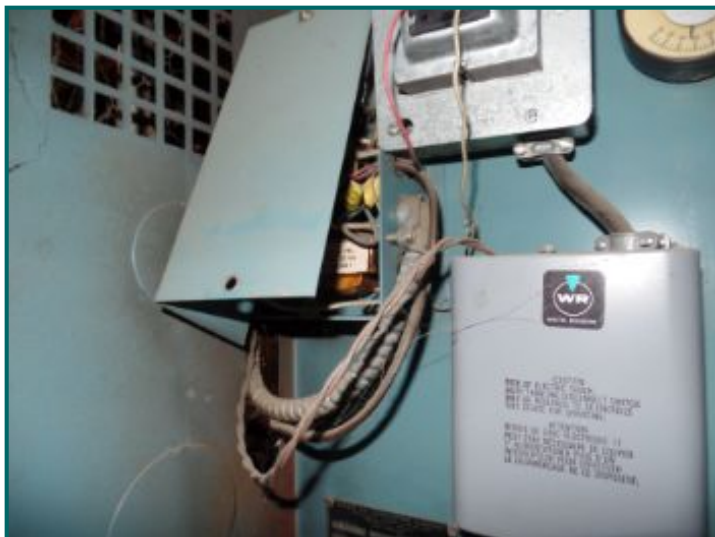
- The boiler functioned normally when tested. However, according to the data plate, the unit is over 40 years old. This surpasses the normal life expectancy for residential boilers. No maintenance log was observed in the boiler area. The inspector recommends consulting the owner concerning boiler maintenance, and evaluation by a qualified HVAC contractor.
- Boiler emergency cut off switch located above boiler unit.
- A loose junction box cover was observed inside the boiler enclosure. This is a shock hazard and should be addressed by a qualified contractor.

Loose cover plate.

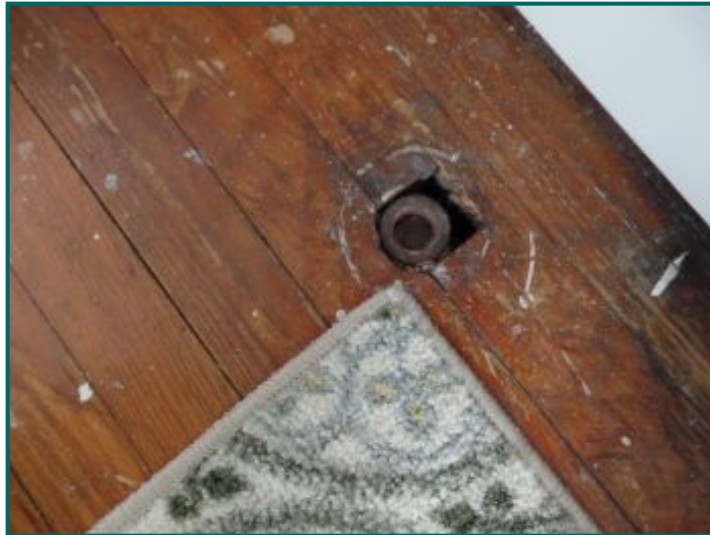
- Several holes were observed in flooring as a result from removing old radiators. Holes should be patched to prevent children from getting fingers wedged in holes.

Hole in floor.

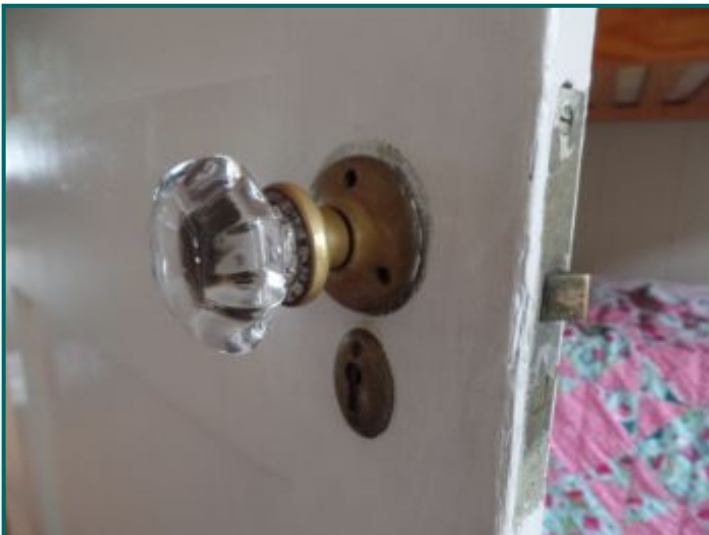
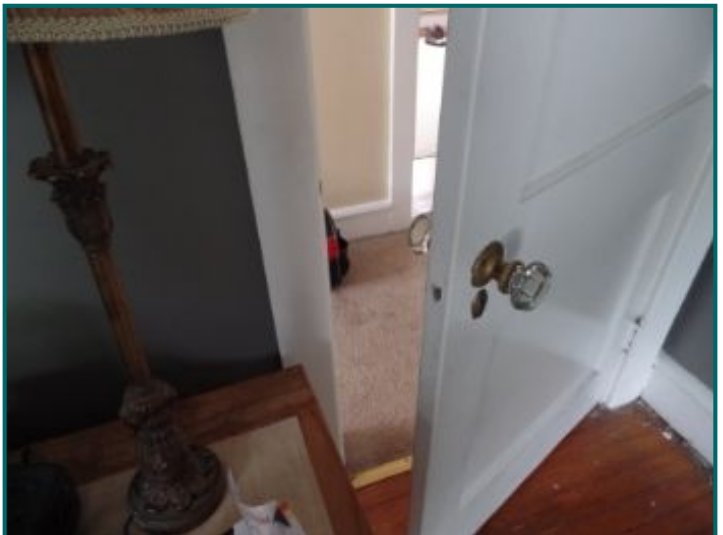
- Missing screws at door knob escutcheon plates observed.
- Rear bedroom door did not latch properly. Latch needs adjustment.

Missing screws.

Inoperable door latch.

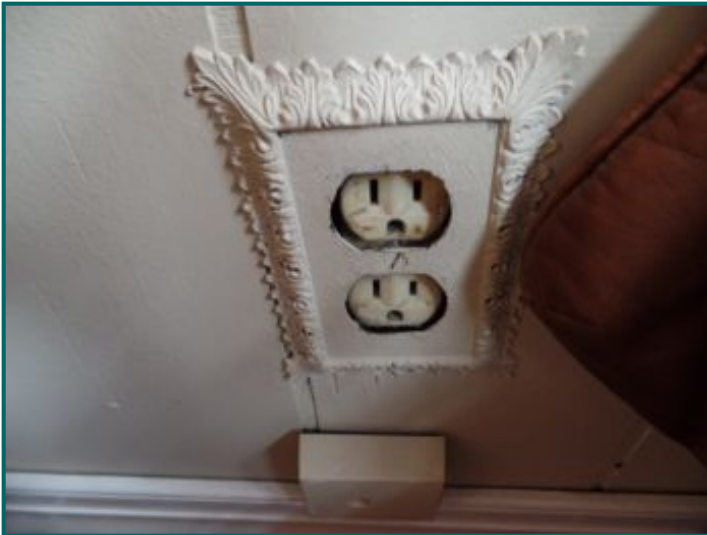
- Open ground observed in two bedroom outlets. This means the outlets are not grounded. This is a safety issue and should be corrected by a qualified electrician.
- Loose mounting observed on ceiling fan right rear bedroom. This is a safety hazard and should be repaired by a qualified contractor.

Open ground.
