Property Inspection Report

South Jersey Area

Age of Home: Built 1925 Size: 1,314 sq. ft.

20 5th Avenue, Cherry Hill, NJ 08003

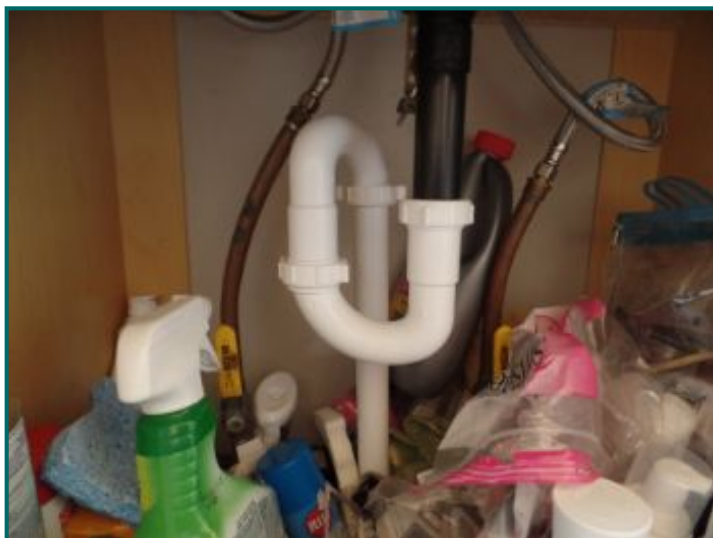
A siphon can develop which empties the trap of water; a condition with the potential to allow toxic sewer gas to enter the living space.

Although this type of trap may have been commonly considered safe at the time the home was originally constructed, as general knowledge of safe building practices has improved with the passage of time, building standards have changed to reflect current understanding. The Inspector recommends replacement of all such traps in the home by a qualified plumbing contractor. If replacement is not practical, the installation of air admittance valves may suffice.

"S" trap, main bath.

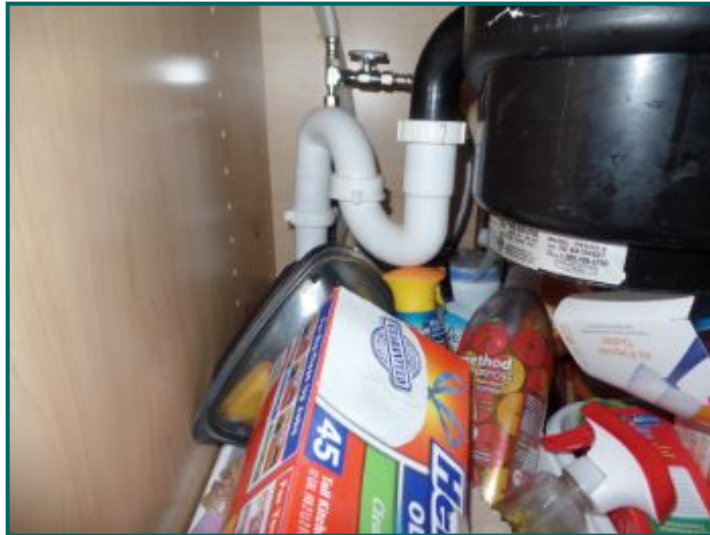
- "S" trap observed under kitchen sink. See "BATHROOM PLUMBING".

"S" trap, kitchen sink.

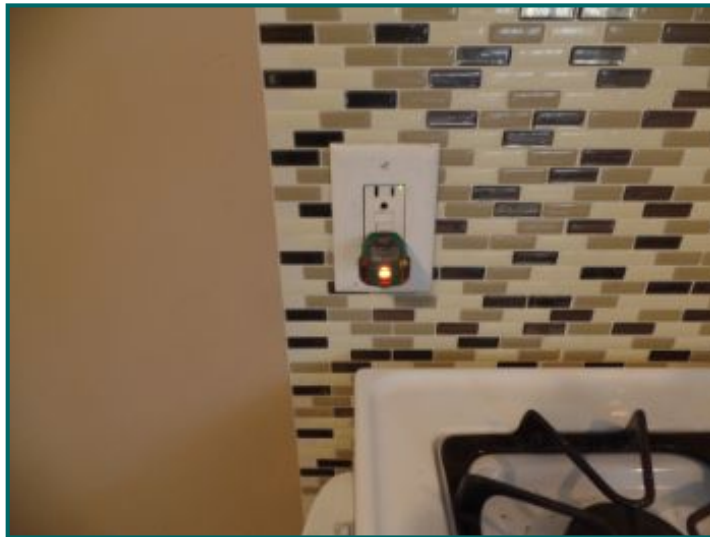
- Open ground observed at kitchen GFCI outlet. Recommend evaluation/repair by a qualified electrical contractor.

Open ground.

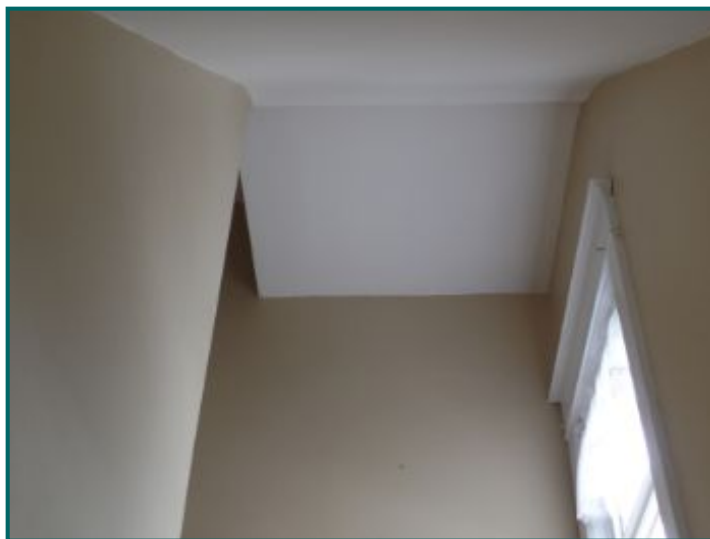
No lighting provided in stairwell.

The Inspector recommends that lighting and switches be installed by a qualified electrical contractor to bring this stairway into compliance with generally-accepted current standards.

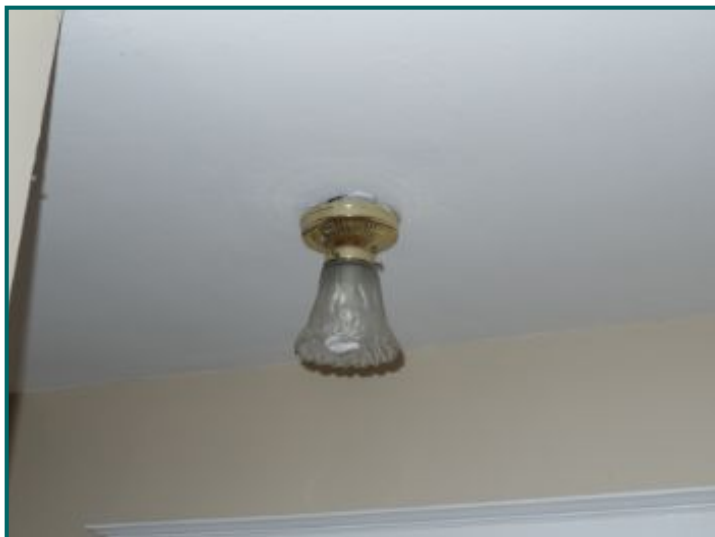
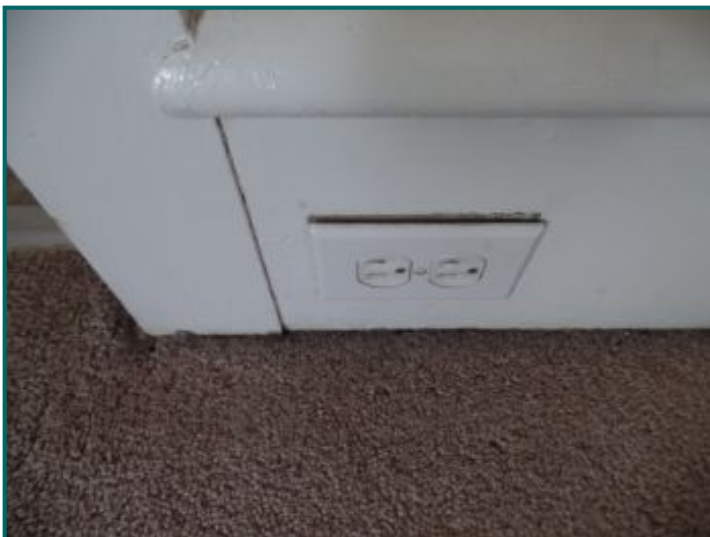
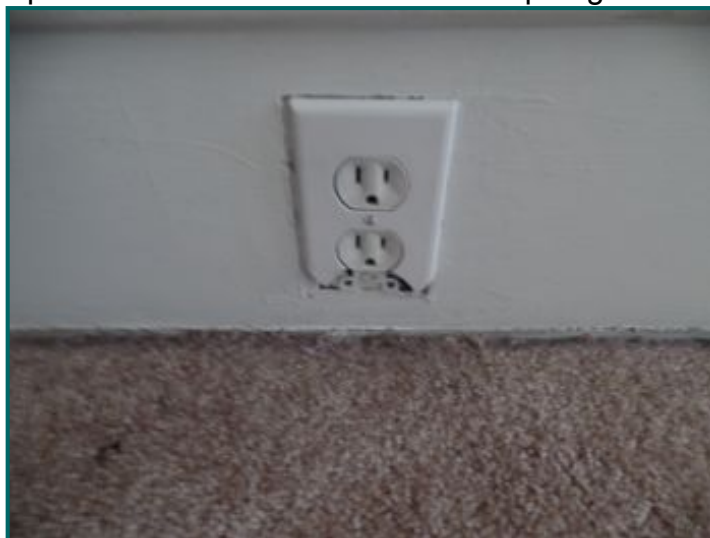
- Replace broken outlet cover in living room.
- Loose ceiling fixture observed in upstairs hall.
- Loose outlet with open ground observed in dining room. Recommend repairs by qualified electrician.

Loose fixture upstairs hall.

Open ground/ loose receptacle.

Broken cover plate.

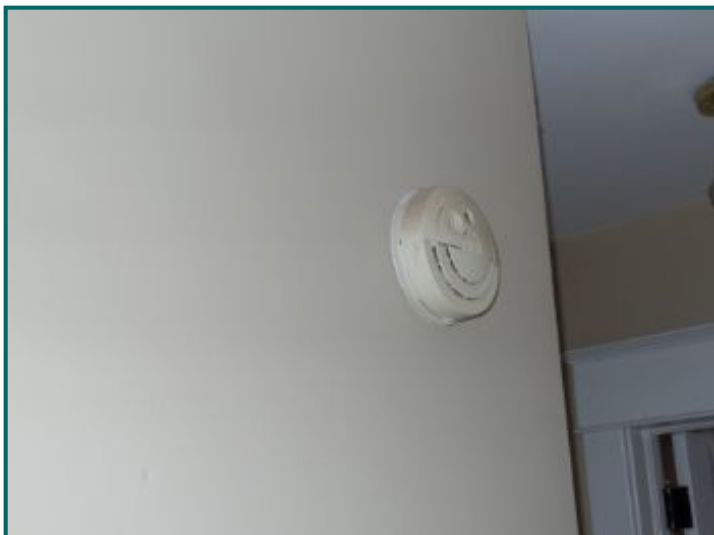
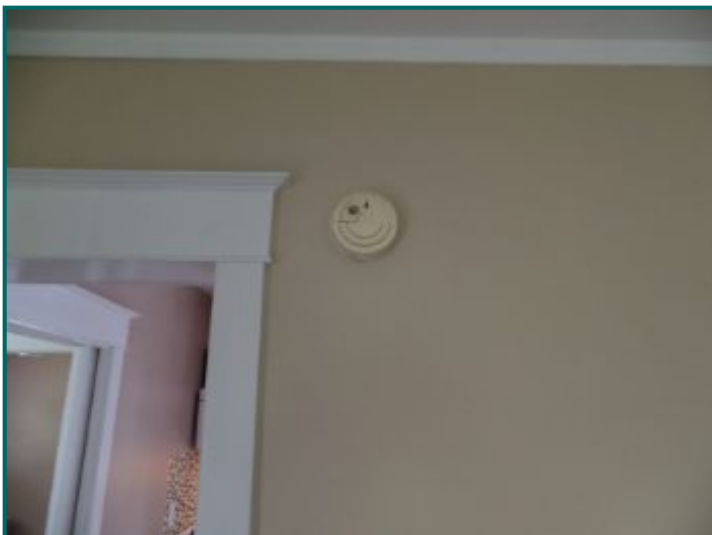
- **IMPROVE:** There was no visible CO (Carbon Monoxide) detector(s) in the home. The Consumer Product Safety Commission recommends that every residence with fuel-burning (gas) appliances be equipped with a UL Listed CO alarm. CO is colorless and odorless and thus impossible to detect without a proper electronic detector. At a minimum, put an alarm near the sleeping rooms on each level in your home. For the most trouble-free operation, I recommend the plug-in type -- not the battery operated type -- with digital readout that tells you the peak CO concentration whenever you push the peak level button.
- Smoke detectors noted at several interior locations. They are older models. Budget for replacement.

Recommend upgrade of older detectors.

Outdated smoke alarms.

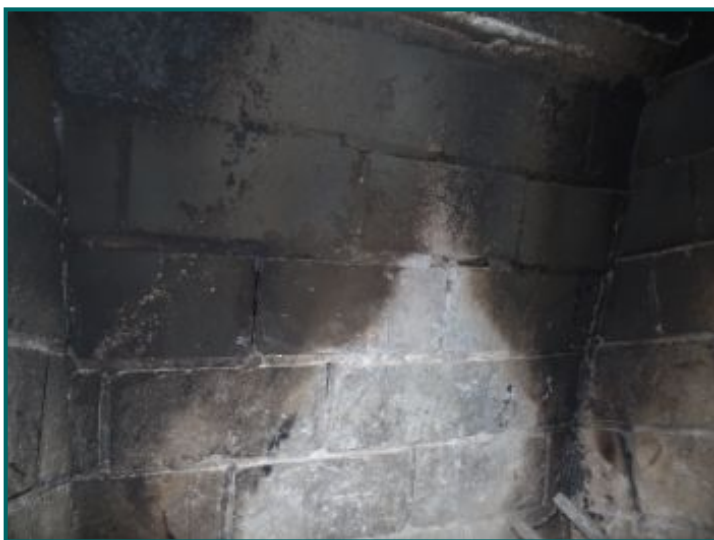
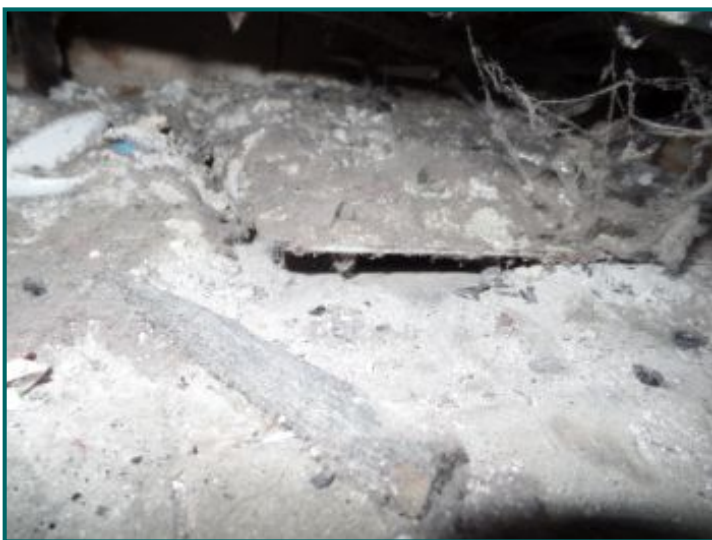
- Loose firebricks were observed at rear firebox, and the ash pit door was detached from the firebox floor. These items should be repaired by a qualified contractor.

Loose fire brick.

Loose ash pit door.

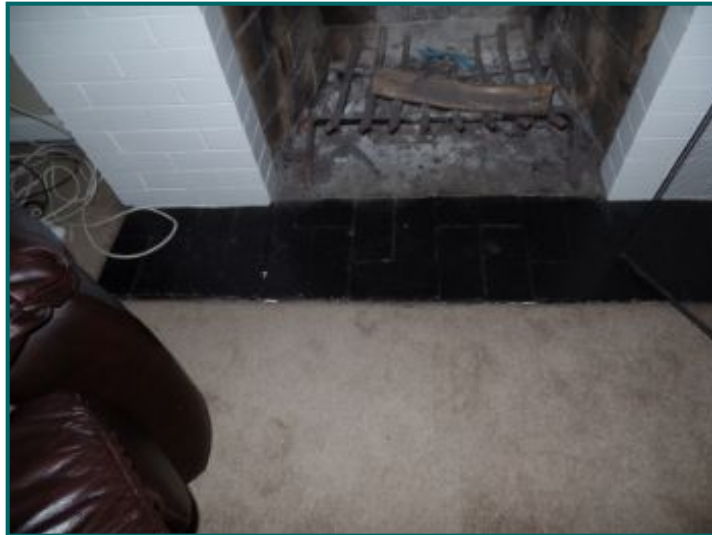
Inadequate hearth extension.
