Property Inspection Report

South Jersey Area

Age of Home: Built 1925 Size: 1,314 sq. ft.

20 5th Avenue, Cherry Hill, NJ 08003

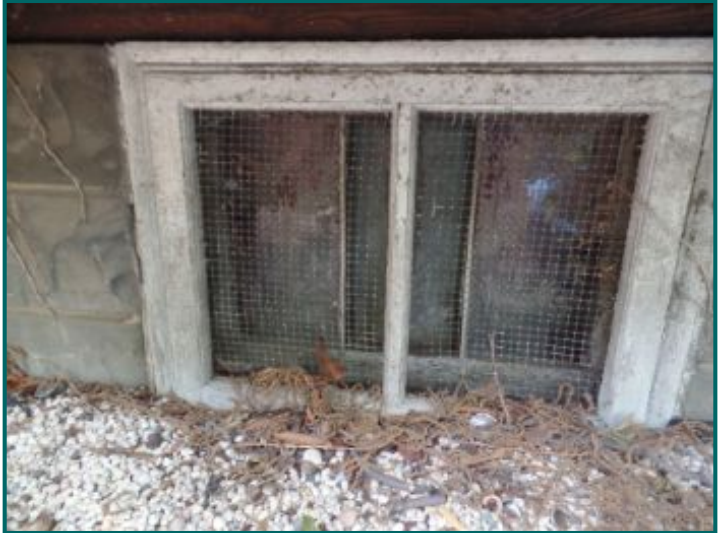
- Some basement window frames were in direct contact with soil. This can lead to moisture and insect damage. All basement windows are in some state of disrepair. The inspector recommends repair and re-painting of basement windows by a qualified contractor.

Wood/soil contact at basement window.

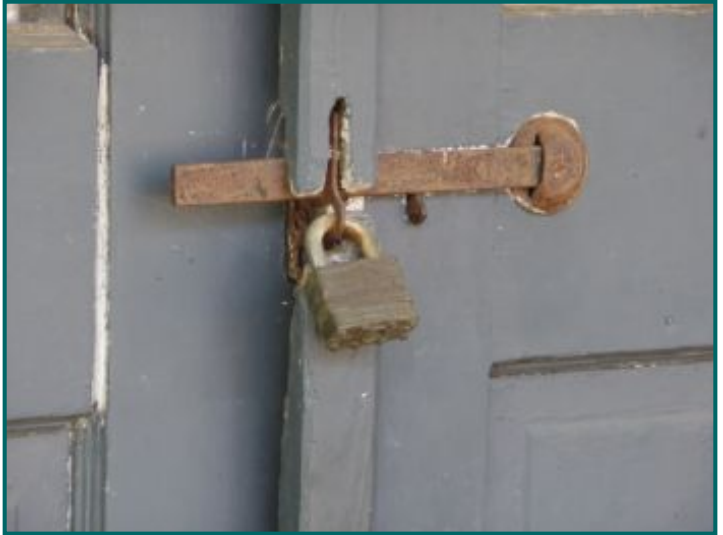
Limitation.

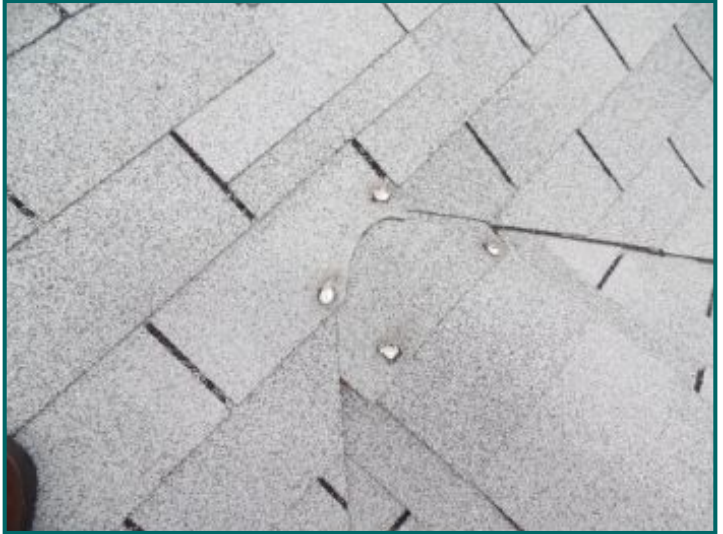
Exposed nail heads.

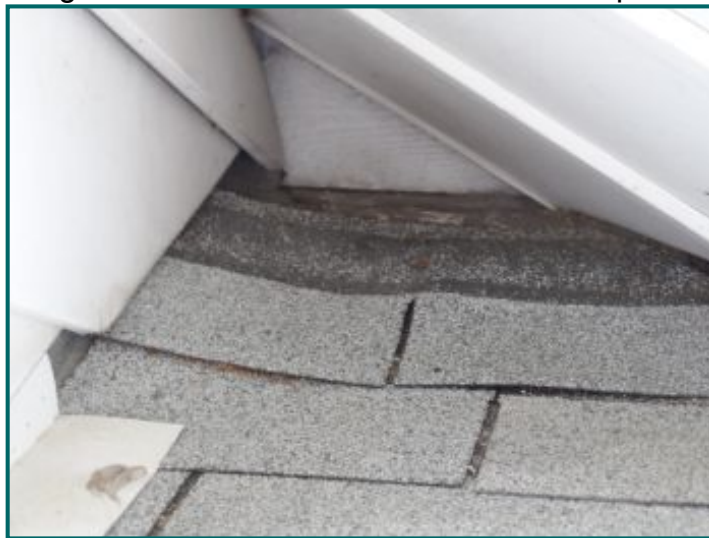
Potential bird/squirrel access to structure.

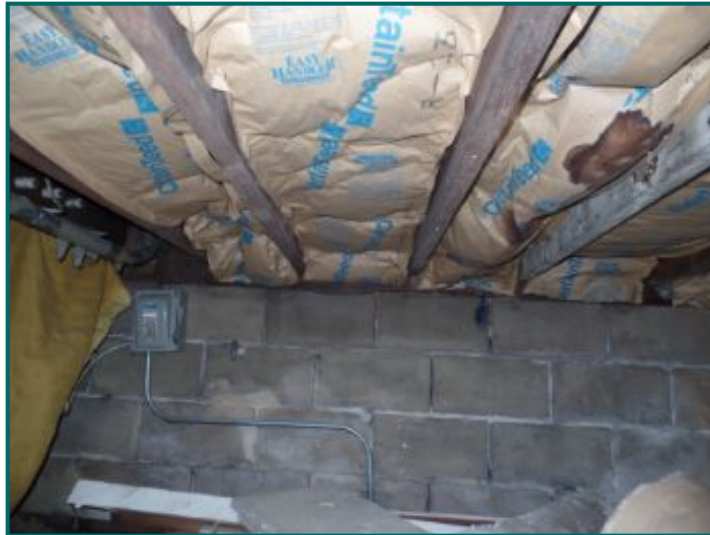
- Insulation appears to be installed incorrectly in crawlspace. Manufacturers instructions typically state that the paper backing is to face the heated living space.

Vapor barrier incorrectly installed.

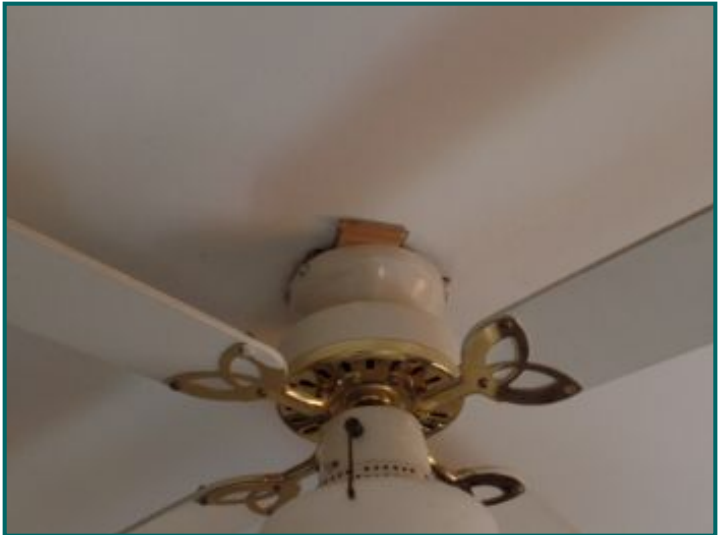
Fixture not properly secured.

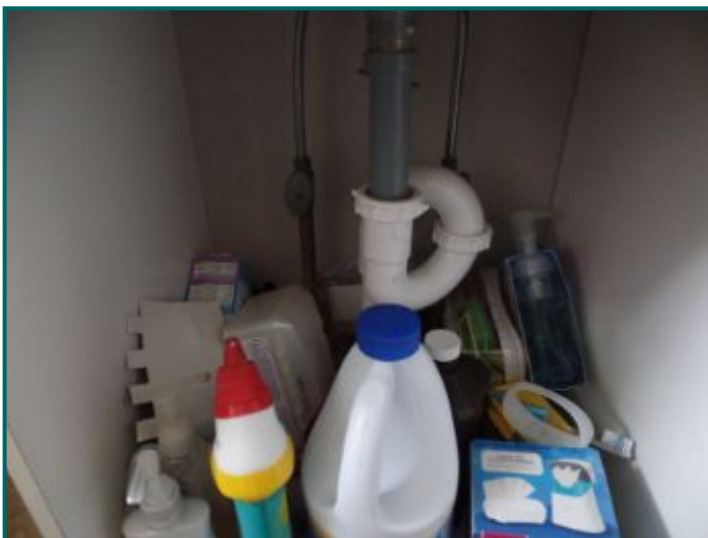
"S" trap, first floor 1/2 bath.
